# Heat flux tests of SiC-fibre reinforced Cu matrix composite

V. Paffenholz, H. Greuner, B. Böswirth, A. Brendel  
IPP

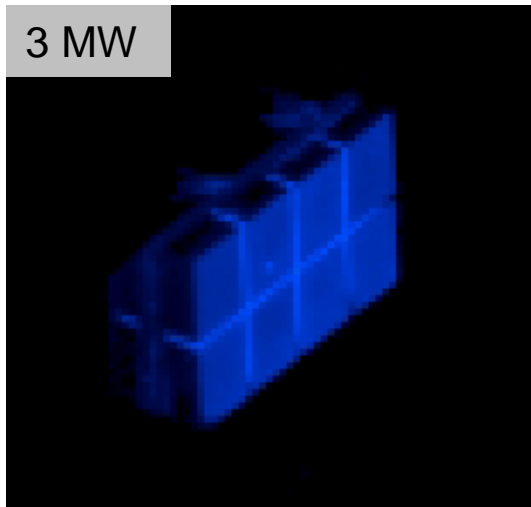
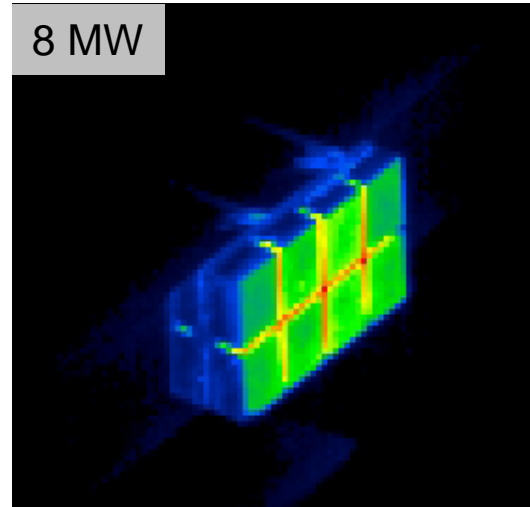
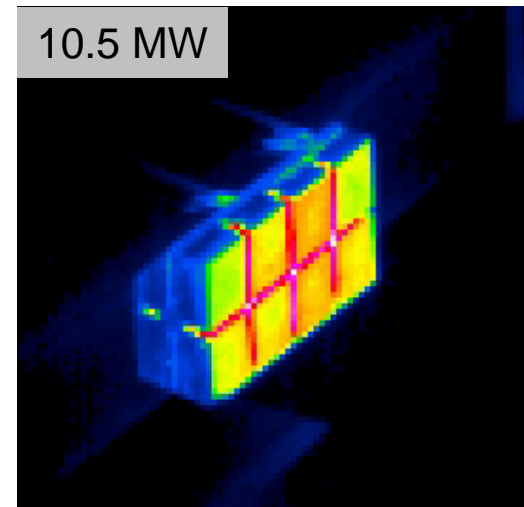
## Screening mock-up 4: 0.2 – 10.5 MW/m<sup>2</sup>

- Uniform temperature distribution
  - Fast and uniform cooling of W-tiles
  - No overheating of W-tiles
  - No damage visible
- Sufficient heat transport at 10.5 MW/m<sup>2</sup>

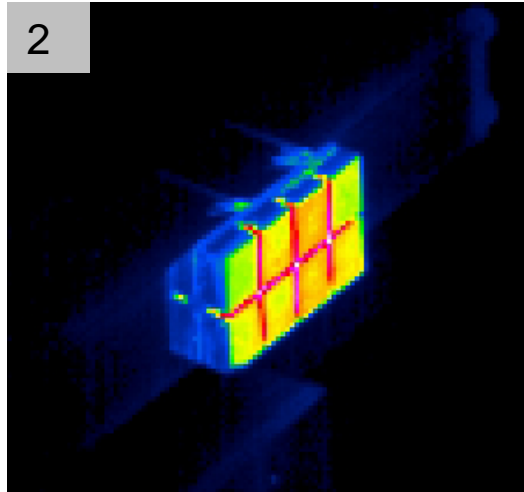
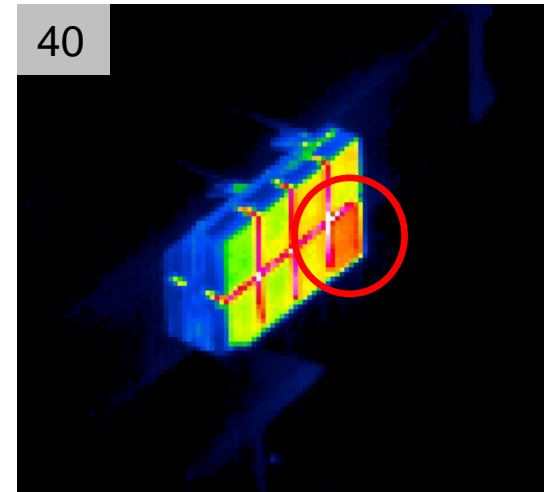
## Cycling mock-up 4: 10.5 MW/m<sup>2</sup>, 40 cycles + 40 cycles (6 W-tiles)

Overheating of  
one W-tile

- Stop after 40 cycles
- Covering of  
damaged W-tile

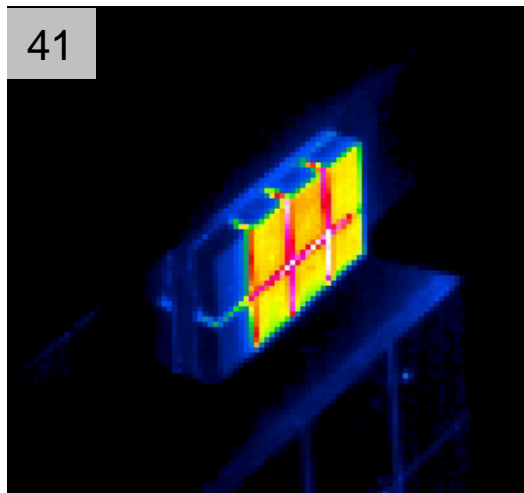
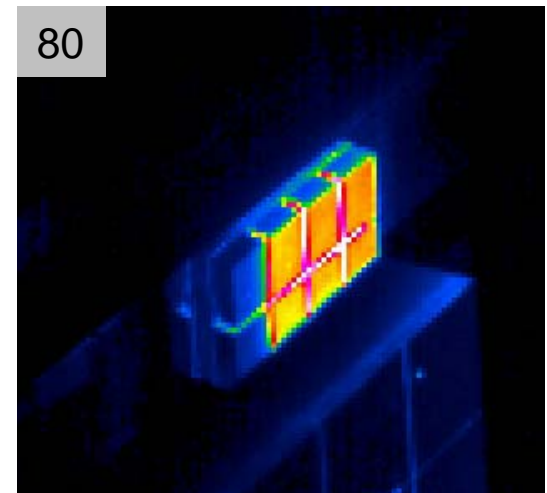
Continuous temperature  
rise at surface of W-tiles

- Stop after 80 cycles

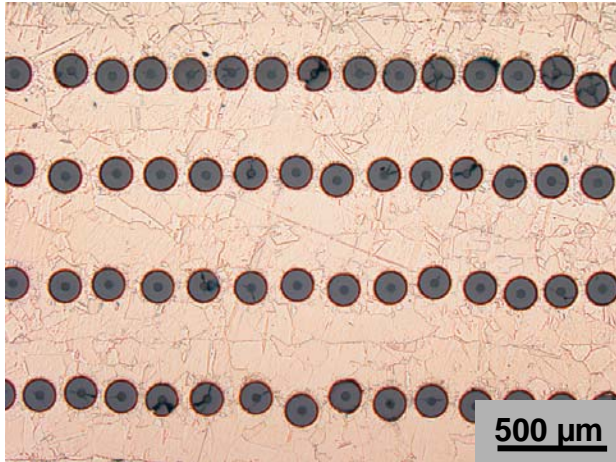
Good bonding  
between layers

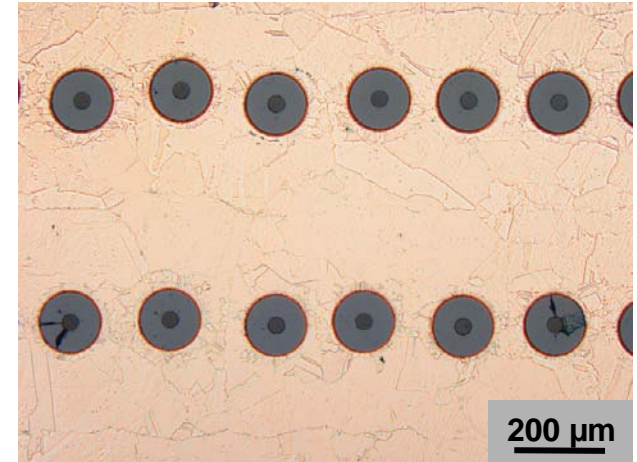
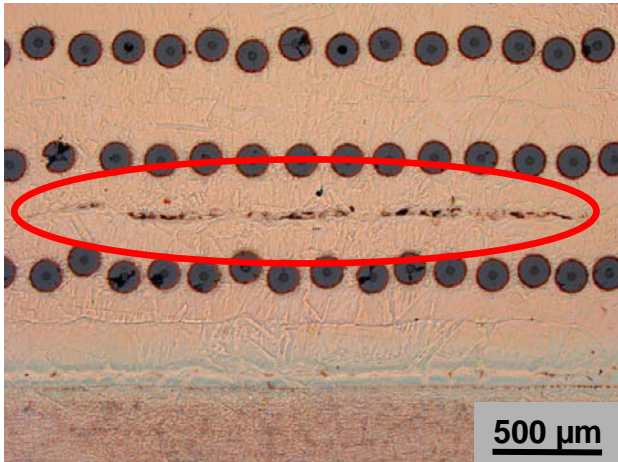
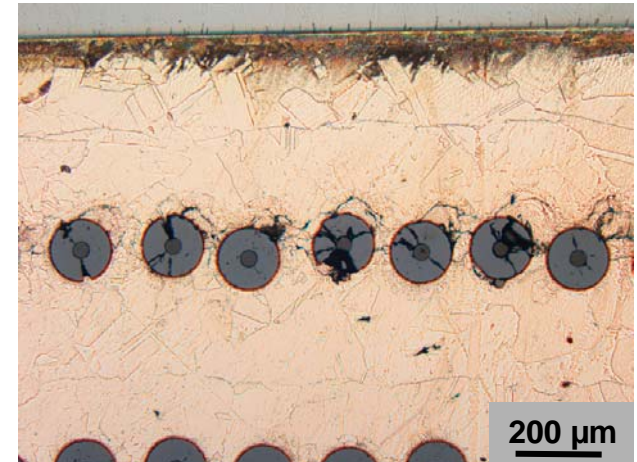
- Localized defects
- No crack growth

Small cracks within the  
matrix at outer fibre layers  
→ different CTE, stress

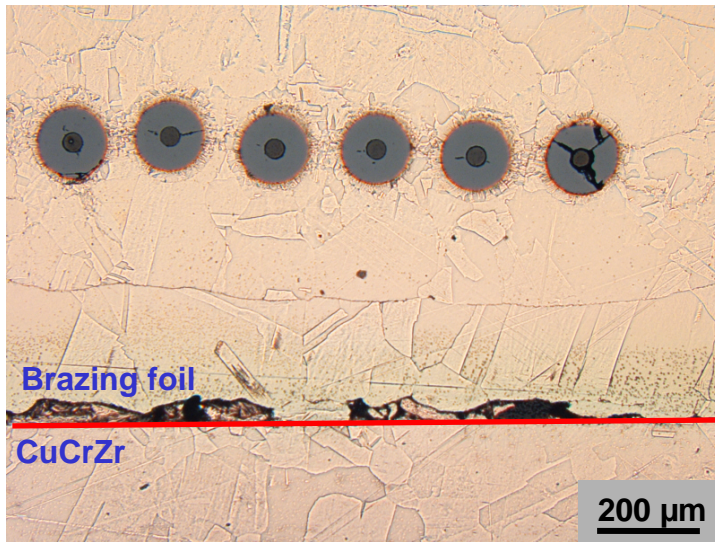
Cracks between brazing foil and CuCrZr/W

→ Bonding needs improvement

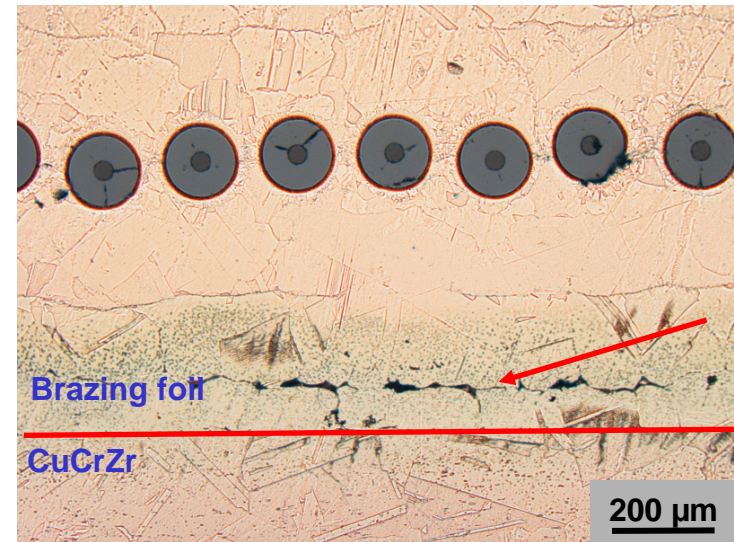
Cracks within the brazing foil (2 brazing foils used)

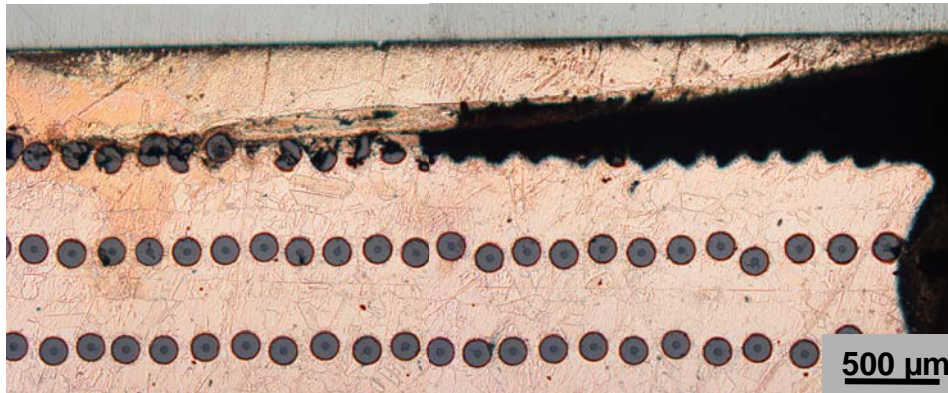
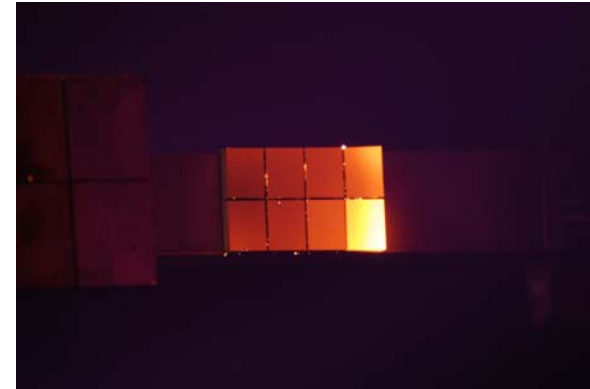
## Overheating of W-tile - cross section of the damage

Failure at the MMC edge

→ Insufficient heat flow, overheating of W-tile

Possible interaction of:

- Different CTE, stress concentration
- Highest temperature
- Weak points can lead to failure (bonding between brazing foil and W/MMC, cracks within brazing foil/MMC)
