# Heat flux tests of SiC-fibre reinforced Cu matrix composite

V. Paffenholz, H. Greuner, B. Böswirth, A. Brendel  
IPP

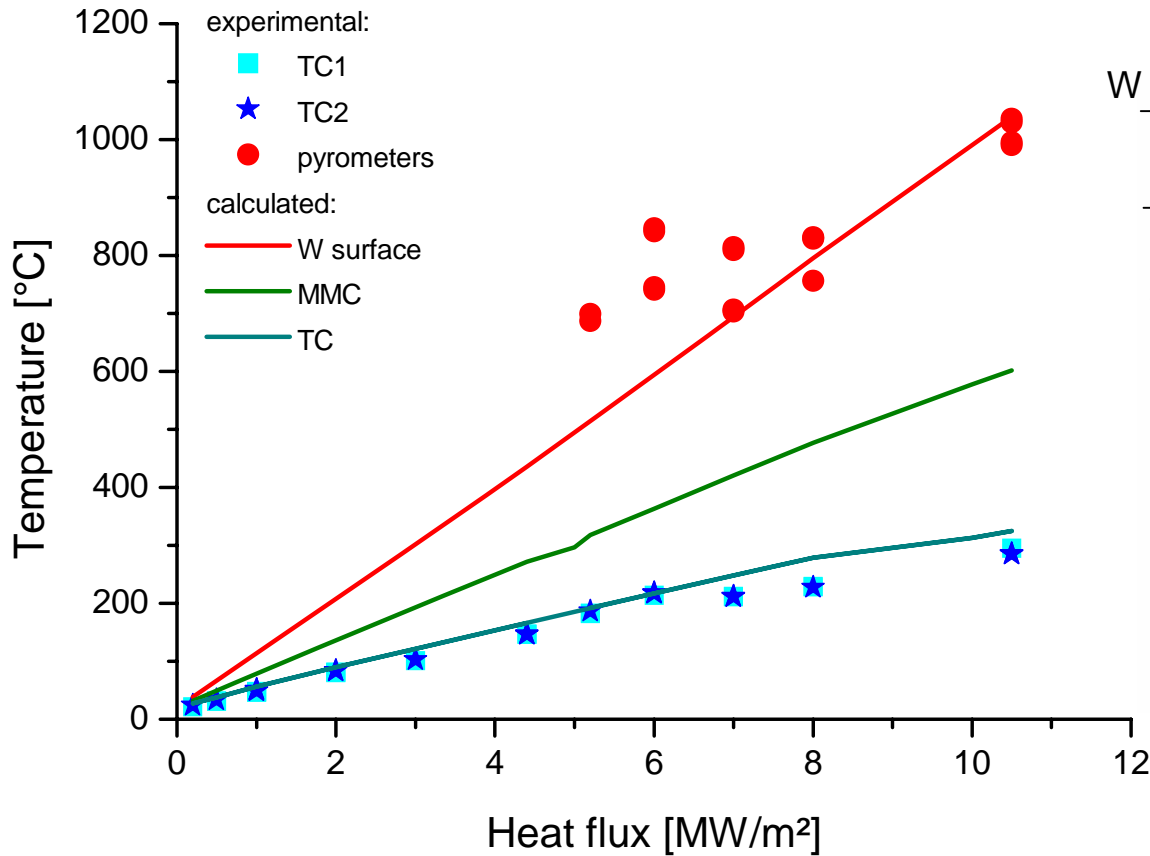
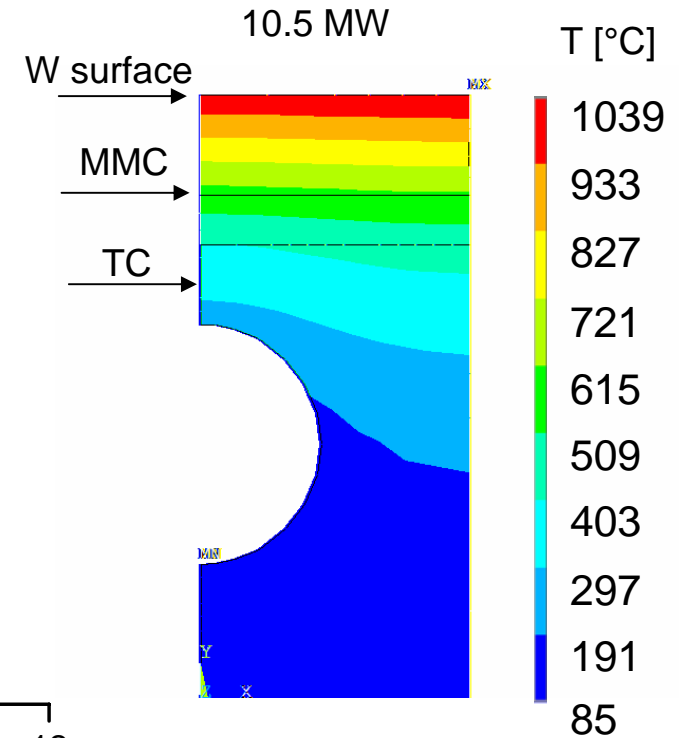
- Good correlation between measured and calculated temperatures
- Highest temperature at the W-surface at the edge of mock-up

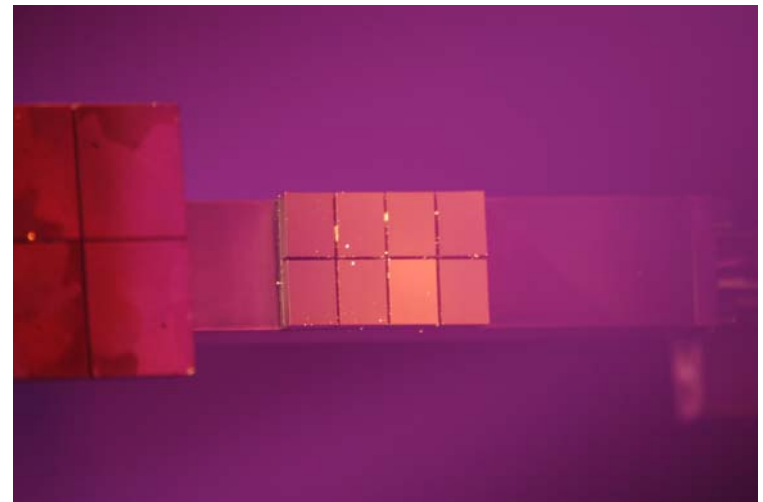
## Cycling mock-up 4: 10.5 MW/m<sup>2</sup>, 40 cycles + 40 cycles (6 W-tiles)

Overheating of  
one W-tile

- Stop after 40 cycles
- Covering of  
damaged W-tile
