Euromater 2005, Czechic

Preparation of Be/Cu modules and their high heat flux tests in China

Presentation by Xiang Liu
*Southwestern Institute of Physics,
Chengdu, ,Sichuan, P.R. China*

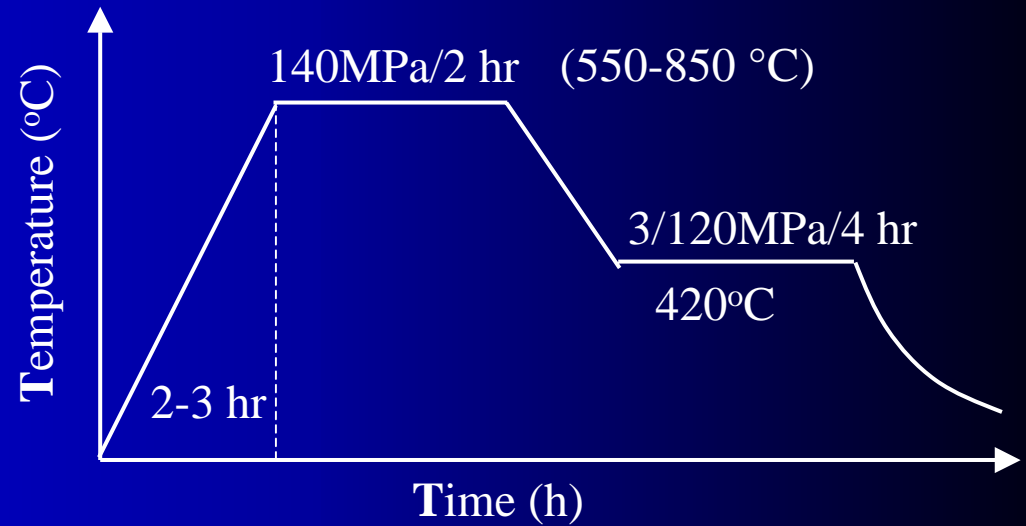
(1) I-VII specimen

HIPing process

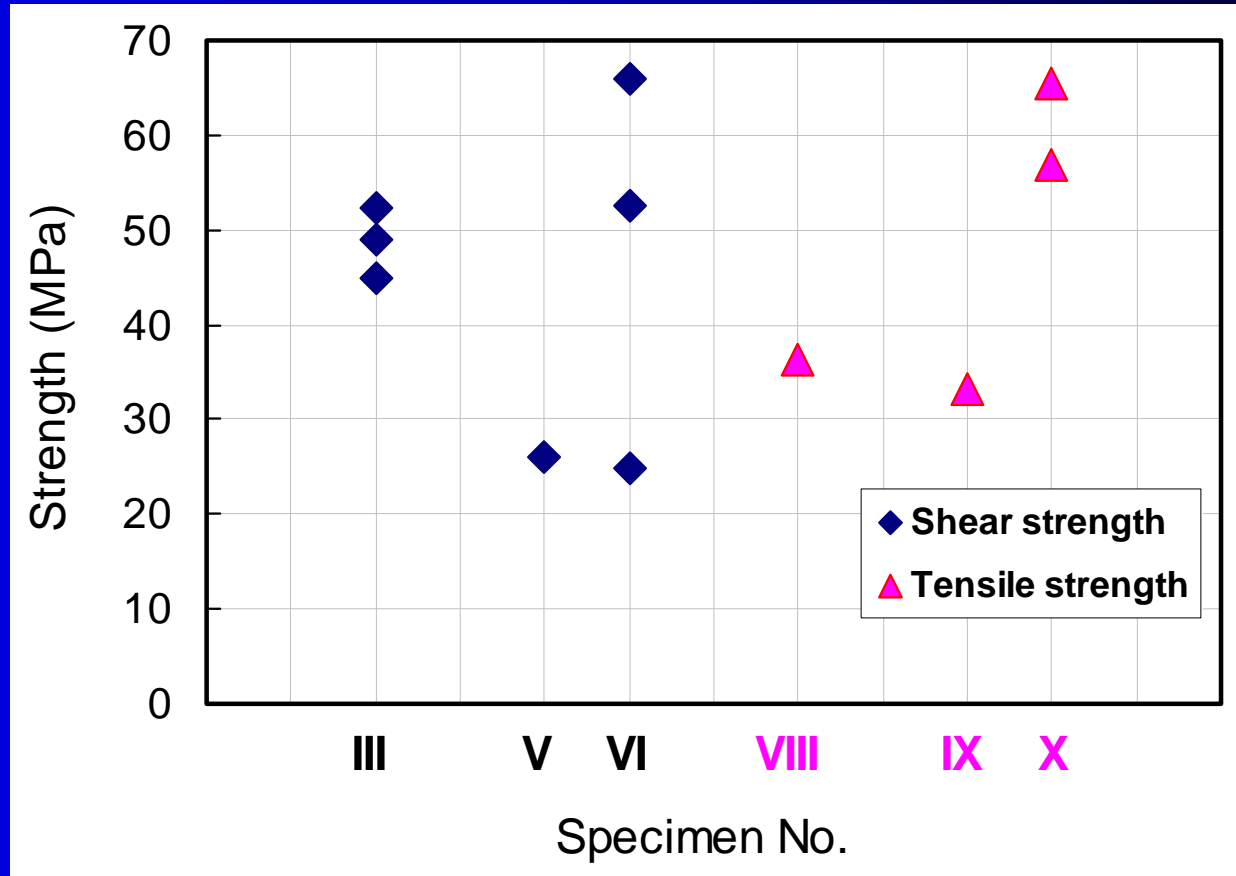
4. Mechanical test results

The data shows certain scattering, indicating some regions were not properly joined or inhomogeneity of the interface.

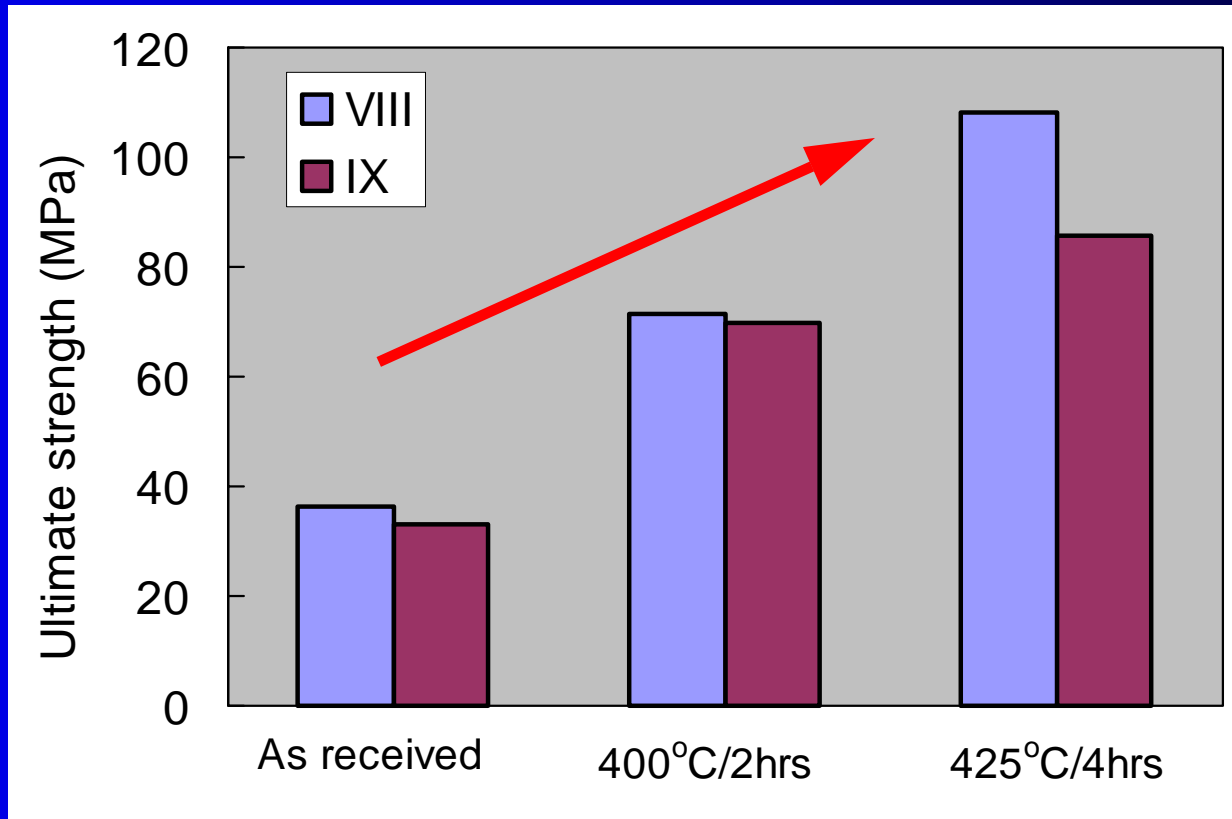
5. Effect of post-HIP heat treatment

The heat treatment is active to increase the joining strength due to the release of the residual stress.

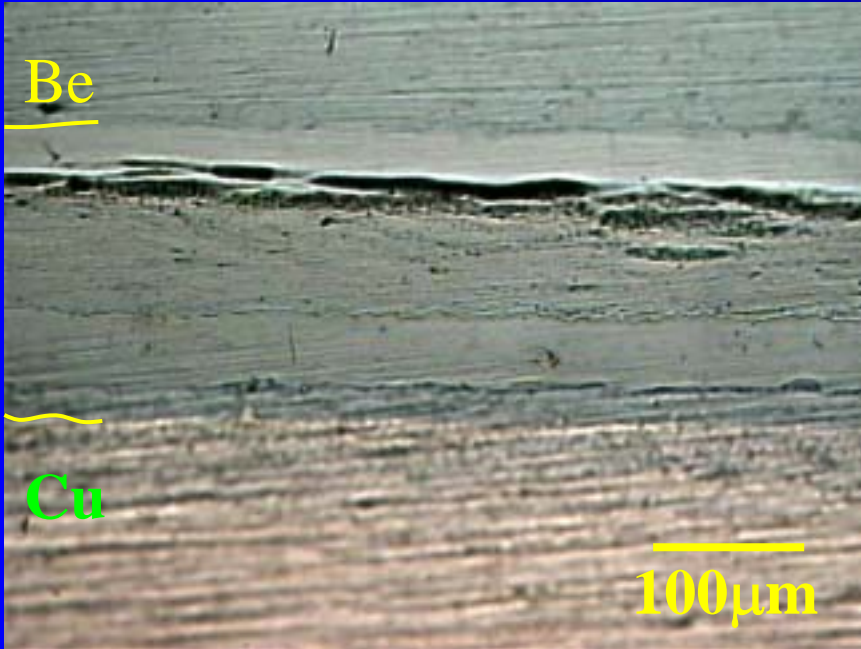
Be/Ti/DS-Cu

With the post-annealing, the joint appears good. Otherwise, the two parts detached.

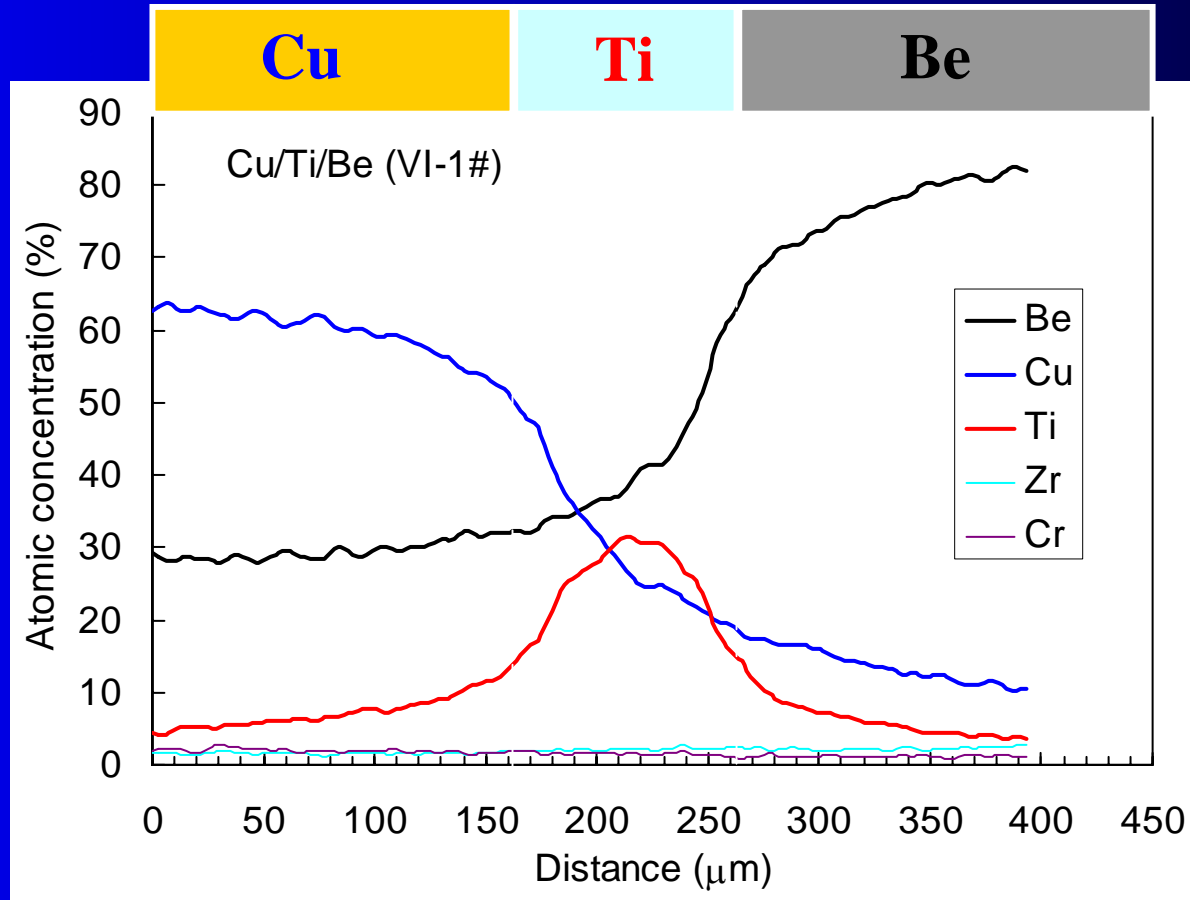
Element distribution across the interface

Gently transition of the elements, indicates sufficient diffusion during the HIPing and good metallurgical bonding between the materials.

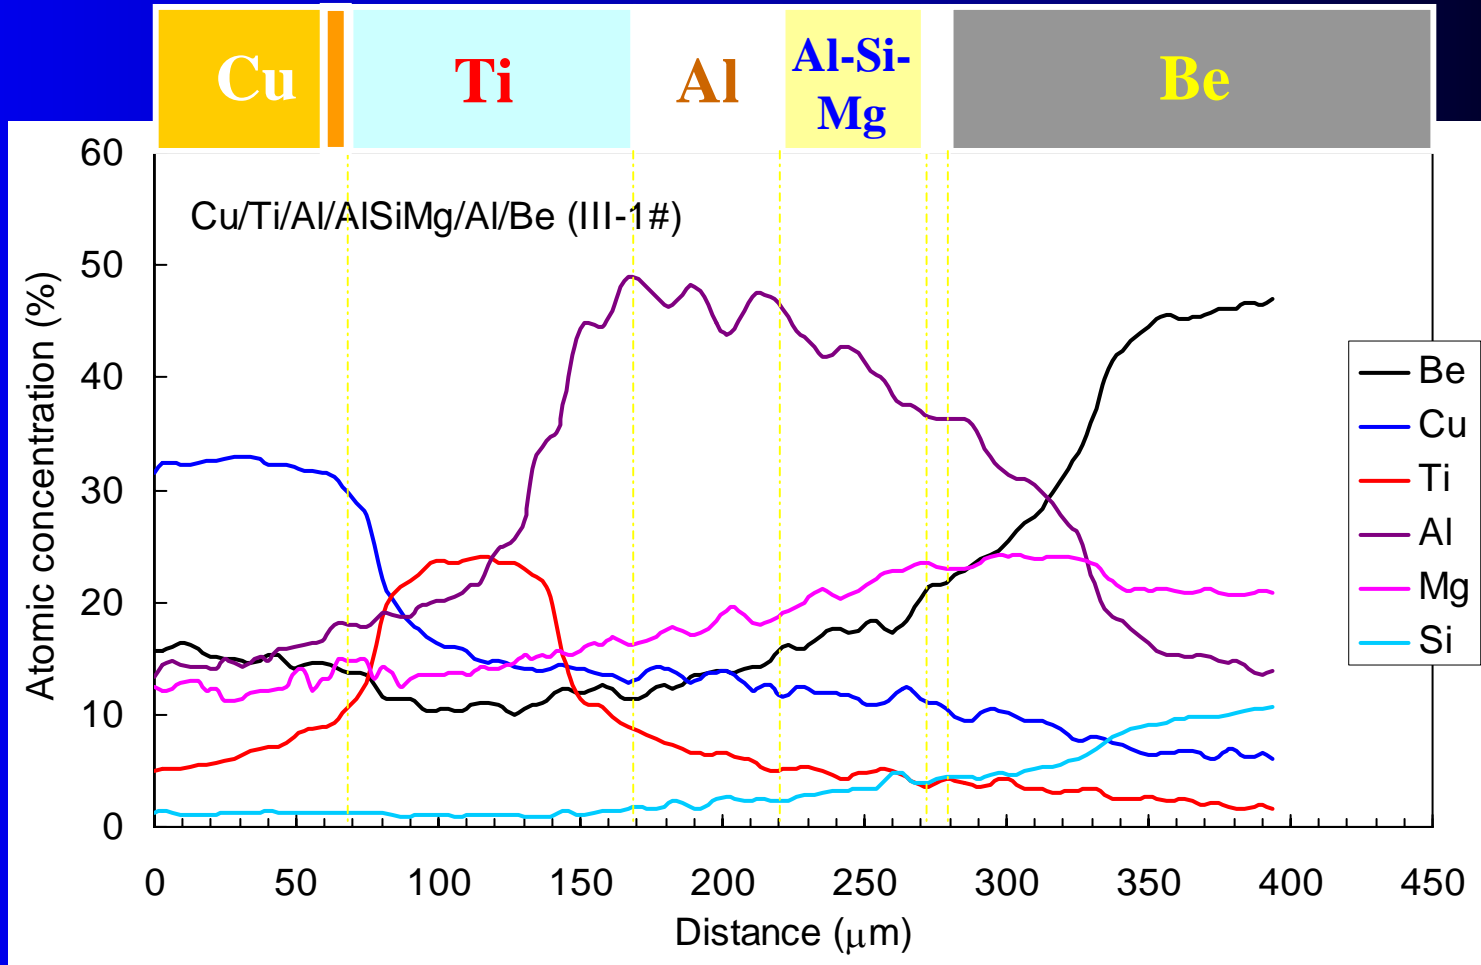
PVD-Cu

PVD-Al

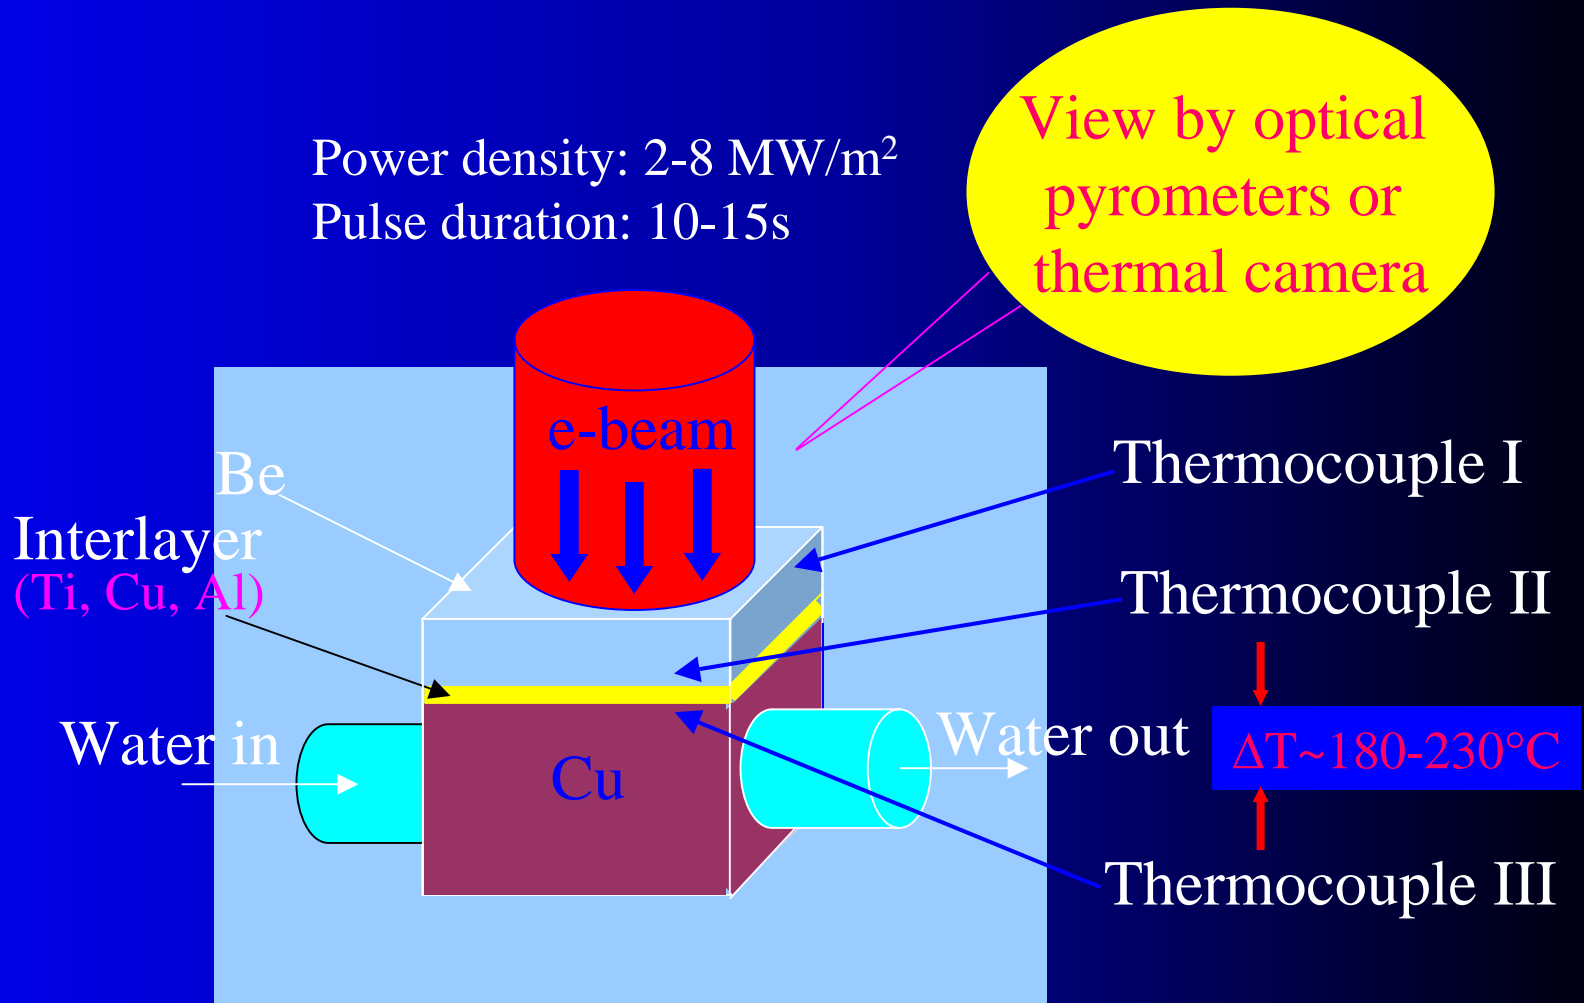
Experimental arrangements of HHF tests of Be/Cu joints

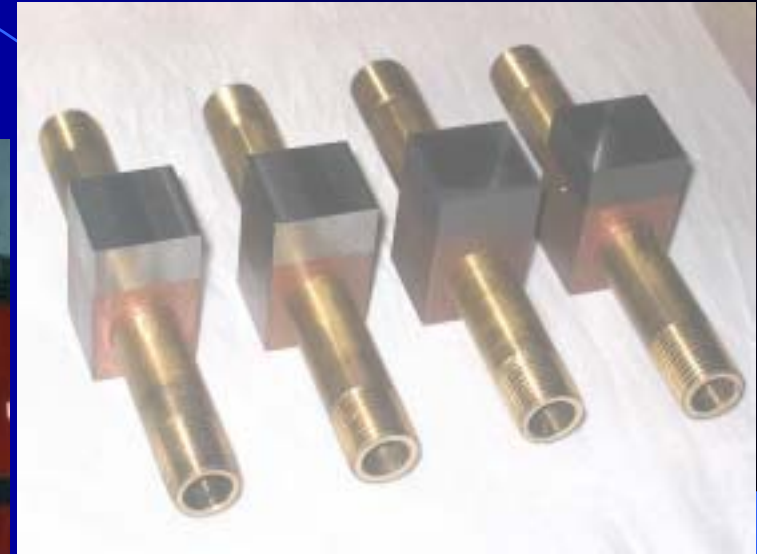
Photographs of HHF testing facility and specimen

Power: 6 KW
Profile: Gaussian
Spot Size: $\sim\phi 20\text{mm}$
Sample Size: 20-40×20-40mm
